Imagery Analysis Report

GORKIY SHIPYARD 112

GORKIY, USSR

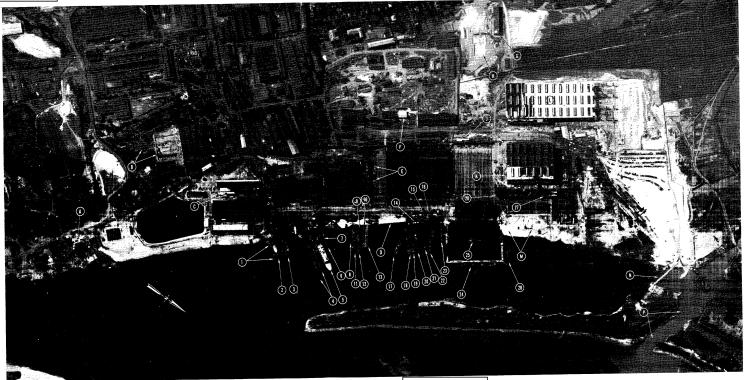
FIGURE 1. GORKIY SHIPYARD 112, GORKIY, USSR,

25X1		Approved For Release 2006 08 22	CIA-RDP79T00919A000200440001-2	25X1
		IMAGERY ANALYSIS	SERVICE	
	LOCA	YARD: GORKTY SHIPYARD 112 MION: GORKTY, USSR COORDS: 56 22N 043 53E		25X1
		KEY TO NUMBERED ANNOTATION	ONS ON FIGURE 1	
	١.	Two Tugboats (LOA of each approximate)	y 130 feet) *	• .
		SORMOVICH Class ACV This craft is resting on a large float		
		ZEYA Class YRSN The large lifeboat observed on the decremains in the same position.	k of the ZEY# on	25X1 25X1
25X1		Two Large Unoccupied Transporter Docks A keel block arrangement is observed o arrangement is similar to those observ	n the floor of each dock. The	
		SOVETSKI AZERBAIJAN Class Train Ferry This vessel is undergoing outfitting.		25X1
		Small Floating Crane This crane is working on the train fer	ry at Annotation 5 above.	- - - -

7.	Floating Crane		
	8.	Rectangular YRSN (LOA approximately 19	O feet)	li-
25X1		Unidentified Small SS (could not be me	asured)	; [
	1C.	Rectangular YRSN (LOA approximately 19	C feet)	\$
25X1 25X1			tting-out at Annotation 3, Figure l unit observed at Annotation 13, tion 19 below is fitted with uating to life rafts) not yet	
		*All measurements have been made by th scaling factors supplied by NPIC/TID. good quality, large scale, near vertic	The measurements were made from

are very dark, whereas on this vessel they are much lighter suggesting that the boilers have not yet been fired.
25X1	12.	Probable APL/YR
25X1	13.	River Passenger Vessel
25X1	14.	Five-Hatch Barge
25X1	15.	Unidentified Scaffolded Probable Submarine Sail (visible length of sail approximately Raised linear imagery possibly equating to a snorkel exhaust is visible on the aft end of the sail suggesting that this maybe for a "J" Class
25X1		SSG. On this position was occupied by scaffolding which had previously contained a "J"Class SSG sail. See Annotation 7,
25X1

16.	Probable Submarine Sail The forward portion of this sail is obscured by the large crane on the quay. Precluding a reliable measurement, however, the after portion of this sail has a raised linear object similar in appearance and size to the snorkel exhaust on the "J" Class SSG sail. This position on the
25X1		quay was unoccupied on
25X1	17.	Large probable APL (LOA approximately 375 feet)
25X1	18.	Unidentified Auxiliary (LOA approximately 175 feet)
25X1	19.	Possible APL/YR It is believed that this is an operational unit as described under Annotation 11 above. For last observation of this vessel see Annotation 12,
,	20.	New Attack Class Submarine (visible waterline length approximately 25X1 feet) It is believed that this submarine probably is not the unidentified submarine observed in this position during the See 25X1
25X1		DDI/IAR-83036, Line Drawings of New Types of Soviet Submarines Observed for the differences contributing to this evaluation. It is possible that the submarine observed had most of the hull 25X1

24.	Floating Crane	
	22.	"J" Class SSG The sail of this submarine is completely scaffolled. A small shack- like structure is positioned abaft the aftermost set of blast deflectors.

23.	Rectangular YRSN (LOA approximately 190 feet)	
	24.	Large Unoccupied Transporter Dock (LOA approximately 440 feet)	
25X1	25.	"J" Class SSG In Launch Basin This submarine is probably resting on the transverse launch cradle. Both sets of missile tubes are elevated and this submarine is fitted with an apparently intact, unscaffolded sail, which suggests that this may be the "J" Class unit observed in the yard in and the unit at Annotation 22 above may be a recently launched unit. See Anno-	25X

26.	Possible Bulk Carrier Under Construction (visible LOA of completed portion approximately 380 feet) This vessel is in an early stage of construction. It probably will be stack aft and have four large cargo hatches.

27.	Probable SOVETSKI AZERBAIJAN Class Train Ferry This vessel is in an early stage of construction. The bow and stern sections are not yet in place. The identification is based on the placement of the athwartship bulkheads and the approximate length of the probable keel plates.

28.	Small Transporter Dock (LOA approximately 250 feet)	
		KEY TO FACILITY ANNOTATIONS ON FIGURE 1	
25X1	Λ.	Building Addition Under Construction Inthis building addition was in an early stage of con-

B. Unidentified Building Undergoing Expansion
A newly excavated area measuring roughly 250 by 30 feet now extends southeast from the original excavation. Better image quality now reveals that the original excavation will probably have five bays running along the width of the original building. It is noted that five POL storage tanks located just south of the original excavation have been or are in the process of being razed. Four small buildings located along the west side of the overhead craneway, positioned just east of the original excavation are also being razed. The razed tanks combined with the new excavation suggest that the size of the original building may be tripled, rather than doubled as originally believed. See

C. Probable Fabrication Building Under Construction
The two westernmost bays of this building have been under construction for about two years and have not changed in appearance for approximately a year. The southeast corner is still incomplete. A third bay now under construction connects the other two bays to the small craft construction hall located just east of this fabrication building. The three-bay building is now believed to be a fabrication building which will support the small craft construction hall. See Annotation A, Figure 5,

Construction continues on the new quay extension. See Annotation C,

Numerous submarine hull sections and frames are in the area. See Anno-

Unidentified Building Undergoing Expansion.
This building now appears to be structurally complete. The construction crane previously noted has been removed. See Annotation A, Figure 3,

G. Laboratory Type Building Under Construction Construction on this building is continuing. A large tower hammerhead crane is working on the south side of the building.

Building Foundation
There are no footings visible as yet; however, the size of the excavation suggests that the building will be roughly 150 by 110 feet.

Approved For Release T20P 5 9E(2RET C A-RDF79T00919A000200440001-2
	IMAGERY ANALYSIS SERVICE
J.	Unidentified Building Under Construction This building is being constructed very close to, or attached to, the rear of the main transverser's winch house. It is approximately teet wide and the length of the completed portion is approximately 150 feet. It is believed possible that this building could be a new winch house to replace the existing winch house which is approximately twenty years old. The construction of this building confirms the premise that the main transverser will not be extended to serve the building at Annotation L of this report.
К.	Construction Hall Under Construction The building appears to be structurally complete; however, the windows are not yet fitted in the roof monitors of the never (third) bay. See
Γ	Large Fabrication/Sub-assembly Building Under Construction Roughly 400 feet of roof sheathing has been added since The construction of the building at Annotation J above (in the path of the necessary transverser extension) confirms that this building will not be a final assembly building. It is now believed that it will serve as a fabrication (north end) and sub-assembly (south end) building. Its end-product will probably be large prefabricated ship sections, which will then feed into the three-bay final assembly building at Annotation K above. If this is correct this new complex will probably be one of the most automated and efficient facilities in the Soviet Union. For last observation of this building see

М.	New Quay Under Construction A pile driver is working at this site. The pile, being driven measure roughly 65 feet long and about half of the piles appear to be in place.

N.	Two Causeways Under Construction These causeways will connect the island northeast of the shipyard to the mainland. The southernmost causeway now appears to be complete, and the northernmost is roughly thirty percent complete. The purpose of these causeways is not yet clear; however, the fact that there are two causeways being constructed, both with roads running across them, suggests that there is or will be a need for a significant amount of road traffic between the island and the shipyard. At present there is no apparent need for this traffic because the island shows a very low degree of activity. It is possible that a construction program of some type is planned for the island, which would justify the two causeways. It should also be noted that photography of showed the island completely inundated by the spring floods.

P. Canal
This canal was cut and dredged through solid land in the summer of
for an undetermined reason.
